Manhole Inspection Summary

Manhole # S31GG1029MH

Insp Date: **2/13/07 8:30 AM**

Location Address: **500 UNIVESITY PKWY**

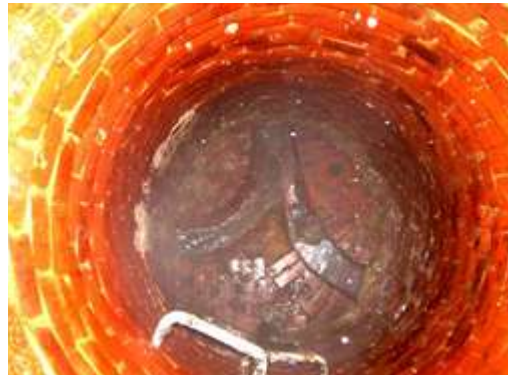
Top View

Bench and Channel debris.

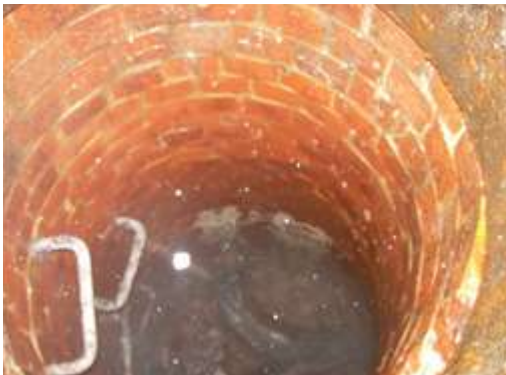
Defect

Frame leaks. Frame offset. Adjustment infiltration.

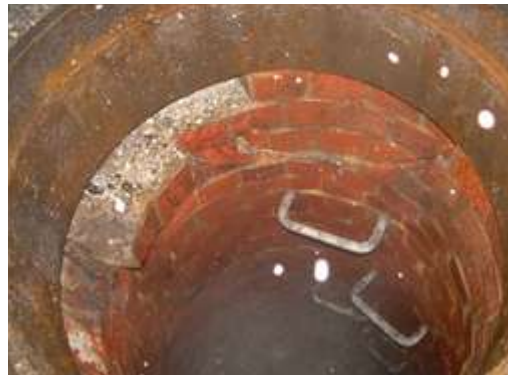
Defect

Frame leaks. Frame offset. Adjustment deterioration, loose brick, cracks and infiltration.

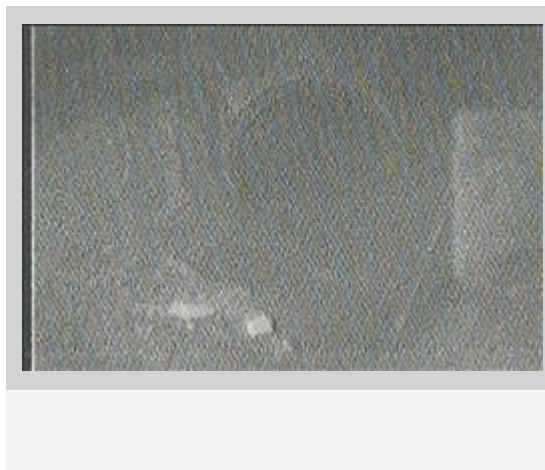
Drop In @ 8 O'Clock

Drop Condition: **Open**
